**SAS Superstructure**

Location: 04-SF-80-13.2 / 13.9

Daily Diary Report by Bid Item

Diary #: 111 Const Calendar Day: 42 Date: 16-Jul-2012 Monday

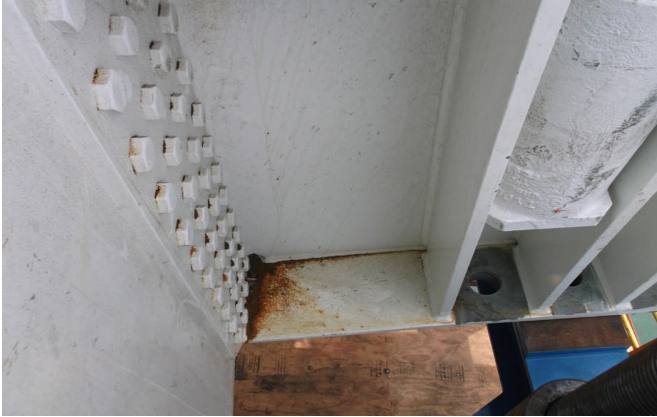
Another item that we re-visited was the rat holes at the bottom of the stiffeners inside the brackets that had been caulked in China. Jim Lumley knew about this issue as he personally oversaw this work in China.

RatHolesNot Plugged

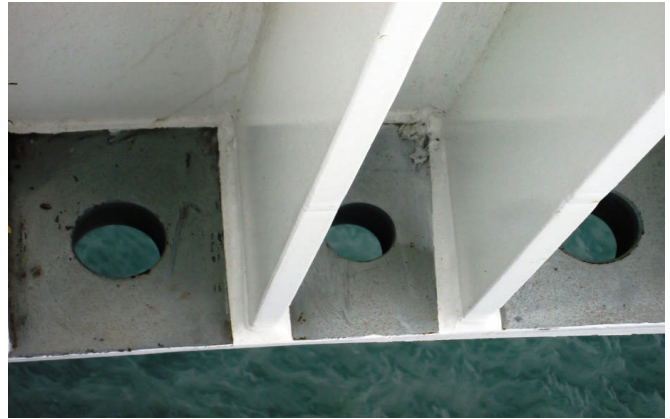
RatHolesPlugged

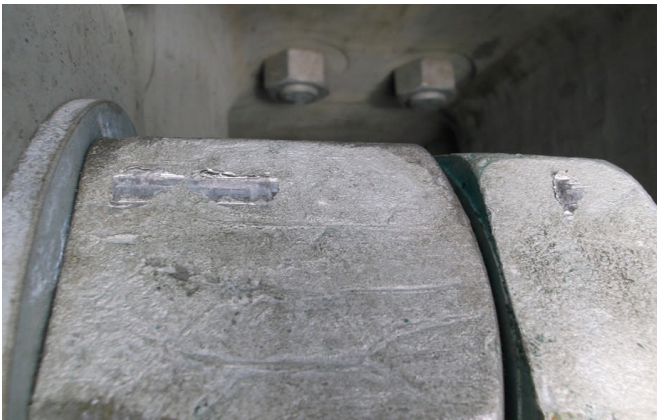
By about 9:30 I was done with this cursory inspection and moved on to the saddle to check the status of work at this location. Since the application of paint at the saddle last Tuesday, there has been no paint-related work at this location. The tie rods had been installed and tensioned with air tuggers removed. The plywood bridging the gap between the two saddles was gone as well. The damage to the saddle did not seem significant at all, but the galvanizing to the newly installed tie-rods was widespread. There were no painters working at this location as all of them are at splice #4.

SaddleTieRodsDamaged (1

Once again, I headed to CCC's konex box looking for Gaya, but I hooked up with Jim Lumley and James Brockman, instead. We discussed the immediate need of getting the saddle painted and cleaned as the placement of the housing was to happen within the next few days. Jim & I mapped out the scope of the work up there on cleaning and painting. James told me that he has to hear it from Andy before he proceeds with the work. On my way back up to the Tower Saddle, I called up Andy and relayed James' message and that we need to get up here soon. He told me that James is within his sight and that he will talk to him about mobilizing to the saddle. While up there, I marked up a few locations for repair, but stopped myself before getting too carried away. I had told Andy and James (as had Jim), that it does not make sense for us (Jim & I) to identify damaged locations only to have it removed during the solvent wiping of the saddle. This had happened on the west deviation saddle. As indicated before, the saddle seems to be in a relatively good shape, as there are not that many damaged areas at this location. The damage to the galvanized and Geomet bolts in addition to the newly installed galvanized tie-rods is more rampant.

Once back on the deck, I talked to Andy and he told me that he needs to talk to Scott Yeager and Adam Roebuck tomorrow, before letting CCC begin the final repair work at the saddle. I asked him to inform me as soon as he finds out and has a clear direction. He agreed. It should be noted that I had put Tony on notice about the imminent work on the saddle when I talked to him earlier this morning at 11:17. Consequently, all parties involved know that there is work to be done up on the saddle prior to the installation of the saddle housing.

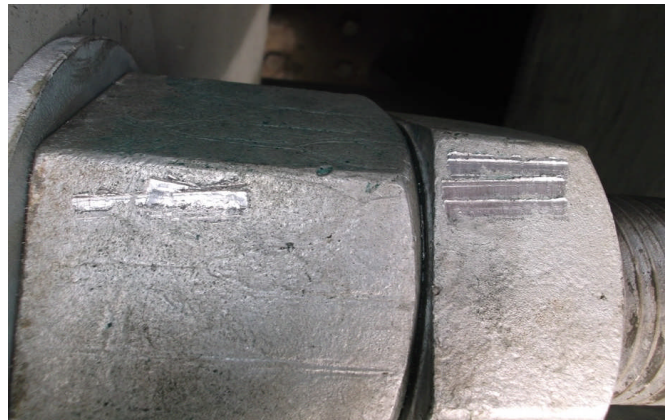
SaddleTieRodsDamaged
